From damaged ugly duckling to sublime Swan.

INVISIBLE MENDING

After Lloyd's of London Yacht Club's Swan 53 *Lutine* was T-boned in a high profile incident before the start of the 2011 Round the Island Race, it needed a very special repair to return her to her immaculate pre-accident condition. **Jake Frith** took a look at how the specialists undertook this mammoth task.

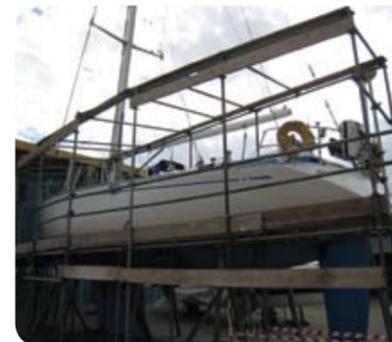
1. Scaffold frame erected...

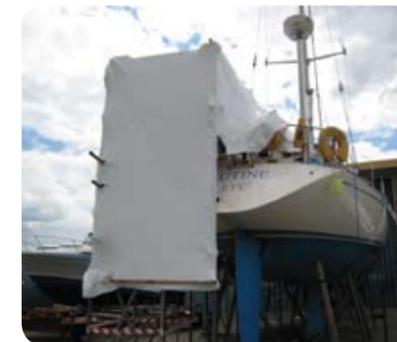
2. ...and covered with marine shrink wrap.

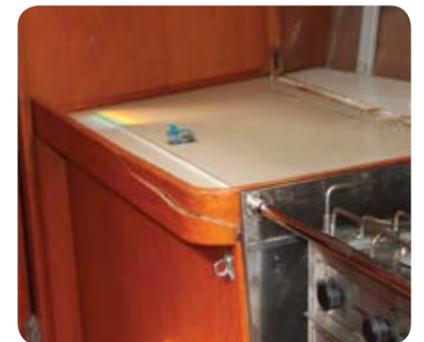
3. The impact had damaged internal woodwork

The interior trim parts were refitted, remade where necessary and returned to bring the saloon back to exact specification.

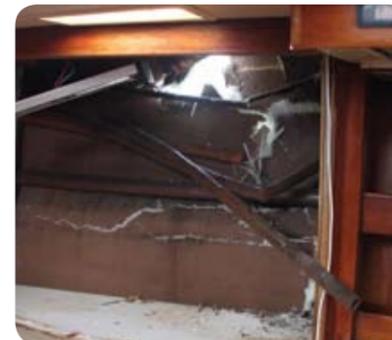
4. The interior was inspected for damage...

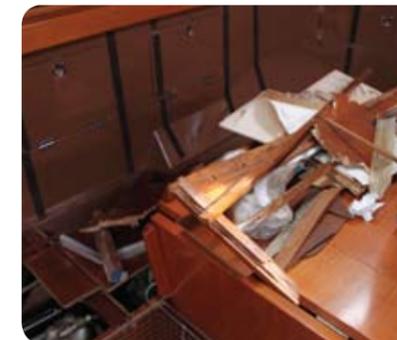
GRP items, such as cars, can be deceptive to evaluate after damage. This is because immediately following any impact, the structure often pops back into something closely approximating its original shape, meaning quite severe damage can look 'not that bad'. With this in mind, the first stage of any repair consists of finding out the total extent of the damage. On the inside, this consisted of careful inspection of all the interior joinery around the impact. You can see how, in this case, the stresses have been spread through the bulkhead and around the fridge compartment, even splitting the teak fiddle round the worktop, along with various electrical conduits and gas piping to the cooker. It was then a case of removing all the broken woodwork, plus everything else that could be broken down around it. On the outside, following the removal of the toerail, a chalk dust of a contrasting grey colour was rubbed into the whole area to show the stress cracks and how far they radiated.

5. ...which was more than first appeared

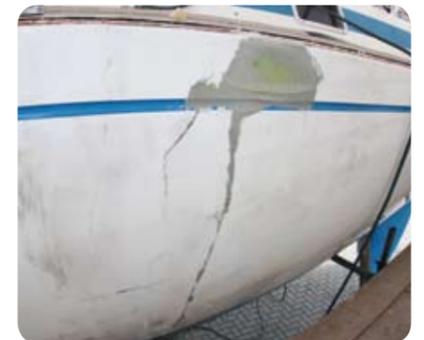
6. First a rough repair to bring the shape back.

The outside of the repair was battened with lengths of flexible softwood screwed in place through the hull. This was because further delaminated areas would be removed from both the inside and the outer layers of gelcoat would be removed as far as the stress cracking reached. For the trademark profiled

Swan stripe moulded into the topsides, a piece of plastic waste pipe fitted the profile perfectly. The wider cracks were filled with a low density filler known as 'pug mix' to further hold things together before the full strength could be built back into the laminate.

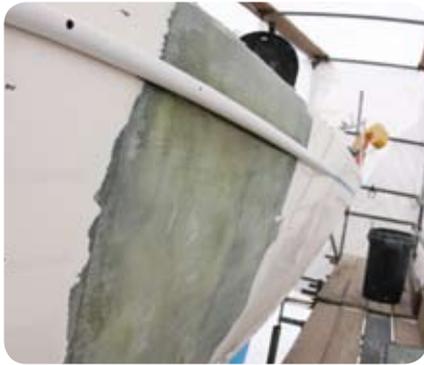
7. Battens placed on the outside.

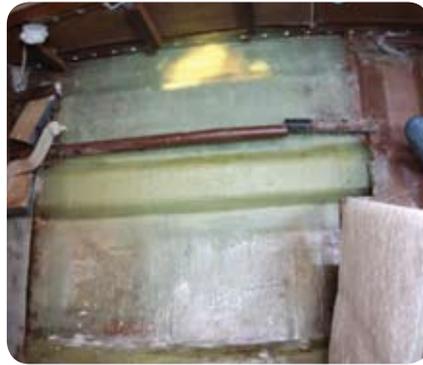
8. The inside built up with resin and matting.

outside, all the loose material could be removed from the inside, first by hand, then by power sanding. Once cleaned, the inside was laid up with resin, chopped strand mat and woven rovings to original specifications.

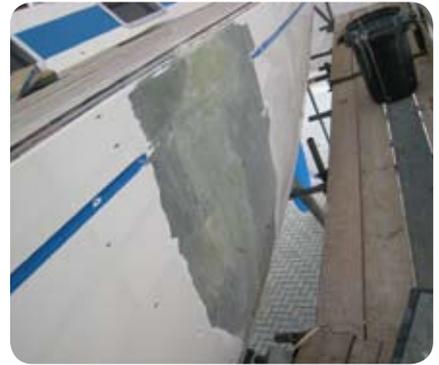
9. External battens removed...

Now that the inside part of the laminate was holding the shape, the screws and >>

battens could be removed from the outside.

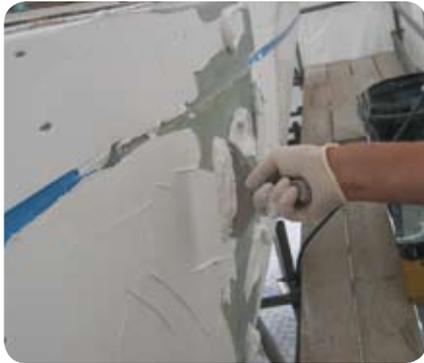
10. ...and outside progressively finished.

The outside area gelcoat was then sanded back, covering an area encompassing all the stress cracking, then woven rovings were laminated in place to reinstate the laminate on the outside. The area was sanded in a square shape to make the glass cloth easier to cut to shape. Following sanding, the area was then filled with pug mix to fill any depressions, blend the edges of the repair area in, fill in the batten screw holes and fill in the texture of the repair cloth to prevent print through onto the topside gelcoat.

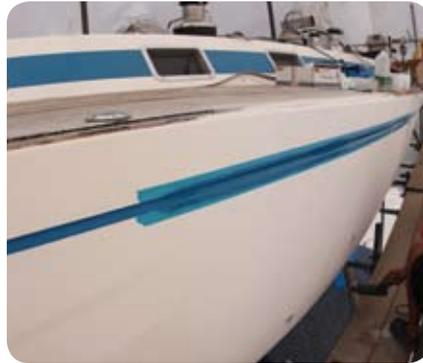
11. Gelcoats colour matched and finished...

Then began one of the more artistic parts of the repair process – the correct colour matching of the finishing gelcoat. According to Mark Goodacre, white gelcoat is rarely pure white, especially once it has aged a few decades. It is a task requiring years of experience to work out whether a dash of red or blue or yellow pigment is required to make a perfect match, and some people just

Once the colour is matched, layers of gelcoat are rolled onto the repair area and sanded down in between. Up to four or five layers are used to support the same depth of polished lustre as the surrounding hull. Some repairers spray on gelcoat, but Goodacres prefer rolling to control the thickness of layers more accurately. Either way it will require flattening down and polishing afterwards.

The accent stripe was then colour matched, masked and built up with blue gelcoat by the same process. The damaged section of aluminium toerail was welded up, re-anodised and refitted, rather than risking importing an incorrect extrusion. Once the outside was polished up and found to exactly match the surrounding area, it was time to return to the inside. This Swan, from new, had been finished on the inside of the hull

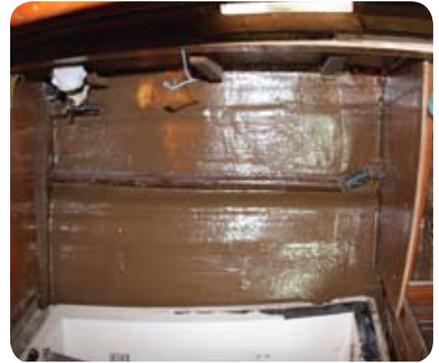
12. ...and Swan spec brown gelcoat inside.

with a brown gelcoat, so this was colour matched and painted on, thus ensuring the original build specification had been adhered to. Although these parts of the hull would be fully covered by interior trim parts, it shows Goodacre's attention to detail that this further stage was undertaken.

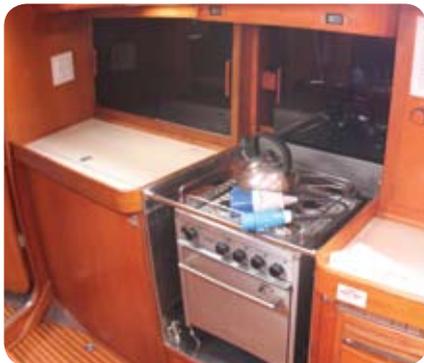
13. Interior reinstated.

Closer inspection of the refrigeration pumps located inside one of the damaged lockers indicated that they had fallen victim to the impact, so these were replaced along with the interior joinery.

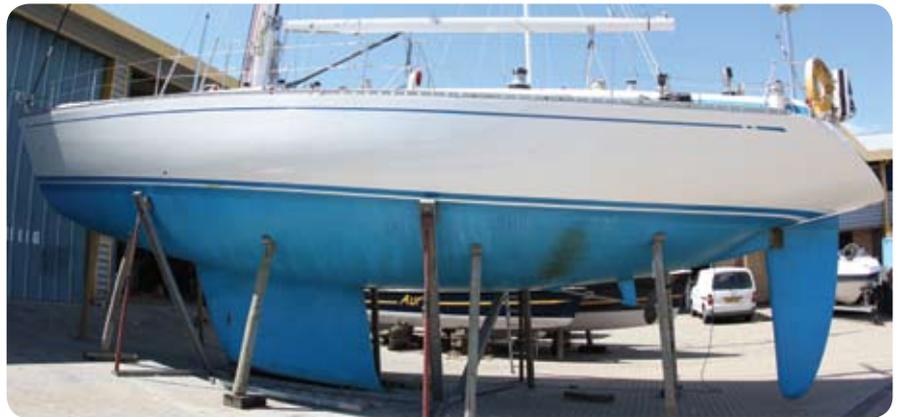
14. Sanded and polished to good as new condition just four weeks after the collision.

Just four weeks after the impact, *Lutine* was returned to the water in her pre-accident condition in good time to commission and shake down for the Channel Race, Cowes Week and the Fastnet.
