JEANNEAU NC14

A gleaming new coat

Our new Jeanneau owner plumps for Coppercoat over traditional antifouling, with very pleasing results

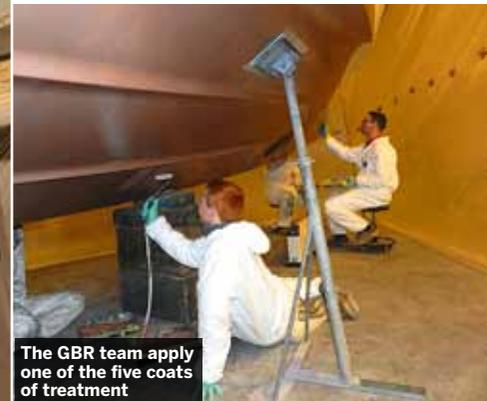
The GBR team apply one of the five coats of treatment

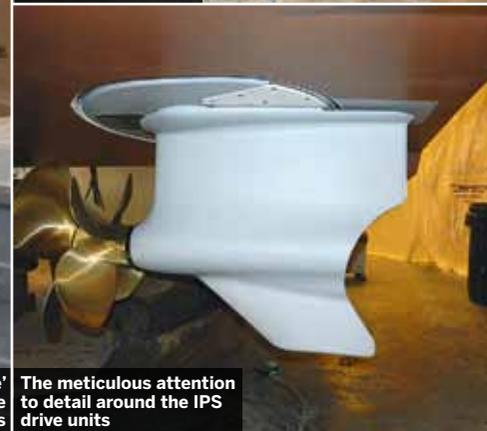
The meticulous attention to detail around the IPS drive units

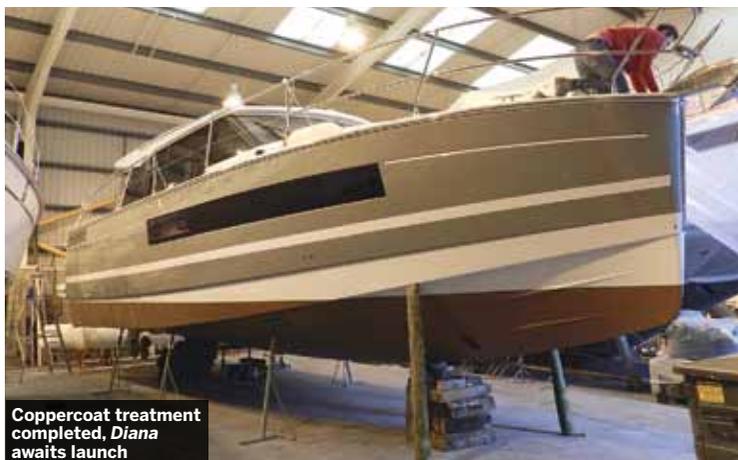
Coppercoat treatment completed, *Diana* awaits launch
